The Mosaics of the Roman Villa of São Simão, Penela, Portugal

Abstract

A preliminary study of the mosaic pavements is presented taking into consideration the decorative motifs depicted, the state of conservation and the interventions made in situ during the archaeological excavation.

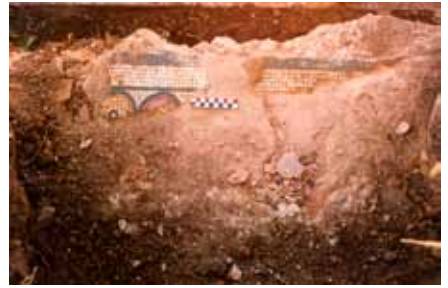
Figure 8
Photographic record of “mosaic 2”.

It features an undulating ribbon motif in a very precarious state of conservation. Unfortunately, this mosaic pavement disappeared (Décor I: 114 pl. 64b) (Fig. 8).

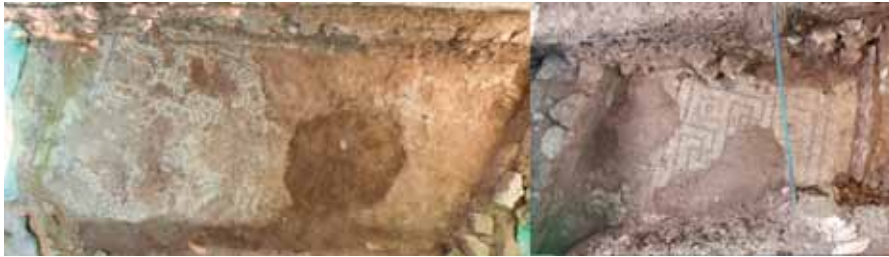
Figure 9
Photographic record of “mosaic 3”.

Does it suggest the possibility of a *triclinium* room? Due to the dimensions that it presents (width of 8, 70 m) and also due to the layout of the mosaic panels (Fig. 9).

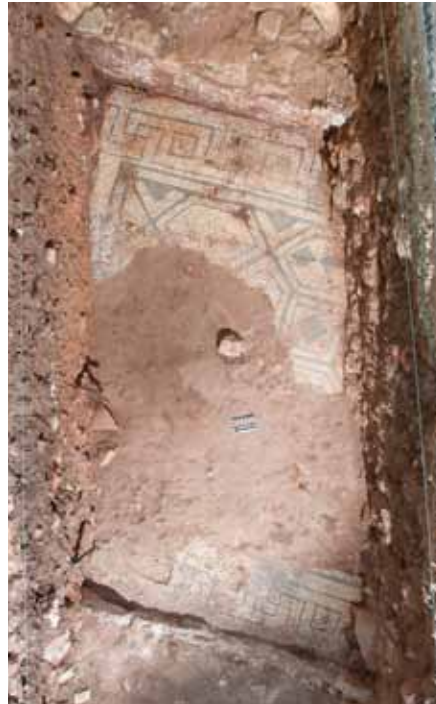
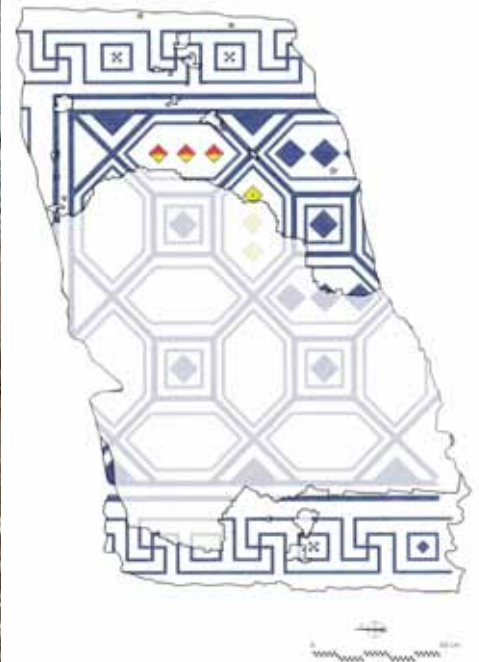
Figure 13
Graphical reconstruction of the pavement of "mosaic 4".

Nº 1 and 1a – It features a swastika-meander of spaced single-returned swastikas with a square in each space; inside the square, there is a crosslet; on the opposite side of the corridor, the same motif with a variant inside the square: lozenge (Décor I: 81 pl. 38a).

Nº 2 – Central corridor motif: outlined orthogonal pattern of irregular octagons adjacent and intersecting on the shorter sides, forming squares and oblong hexagons (Décor I: 260 pl. 169a). In the centre of the octagon, the central square is filled with a lozenge. The interior of the hexagons is filled with bichrome and polychrome lozenges, of irregular size.

According to the presented graphic diagram, the following description is presented (Figs. 13, 14):

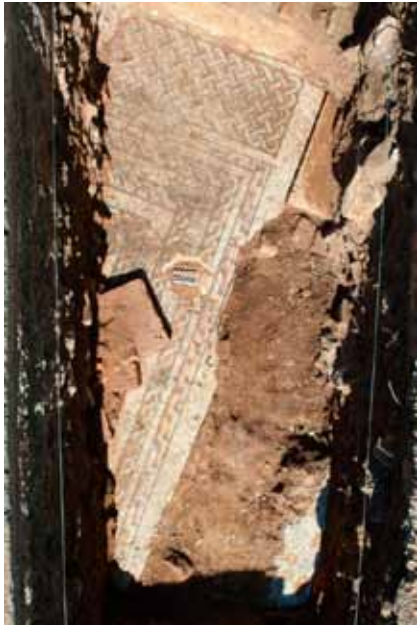
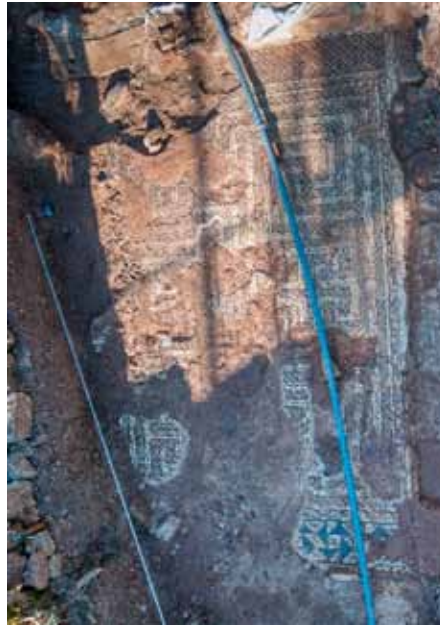
Figure 14
Hypothetical interpretation of the pavement of "mosaic 4".

Nº 2b – Monochrome band with white tesserae (Décor I: 26 pl.1y);

Nº 2c – polychrome band with two-strand guilloche on a black ground (Décor I: 120 pl. 70h,j);

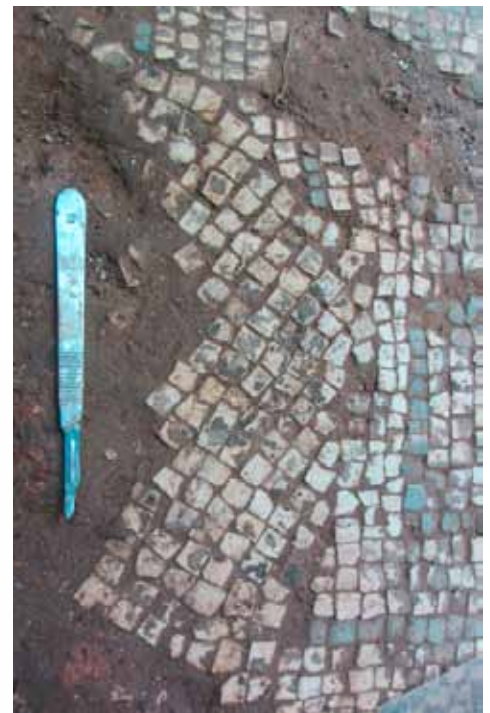
Figure 24
Ancient restoration work done with white *tesserae* placed in a distinct orientation.

At the present time the identification of its function is not possible (Figs.15a-b). It possible to verify that the pavement had already had many restored areas in its time through the rectification of gaps with simpler materials, like *opus Signinum*, confirming this *Villa's* ample diachronic occupation. As a consequence of the restoration works, it would be possible to maintain the use of the compartment regardless of the aesthetic appearance.

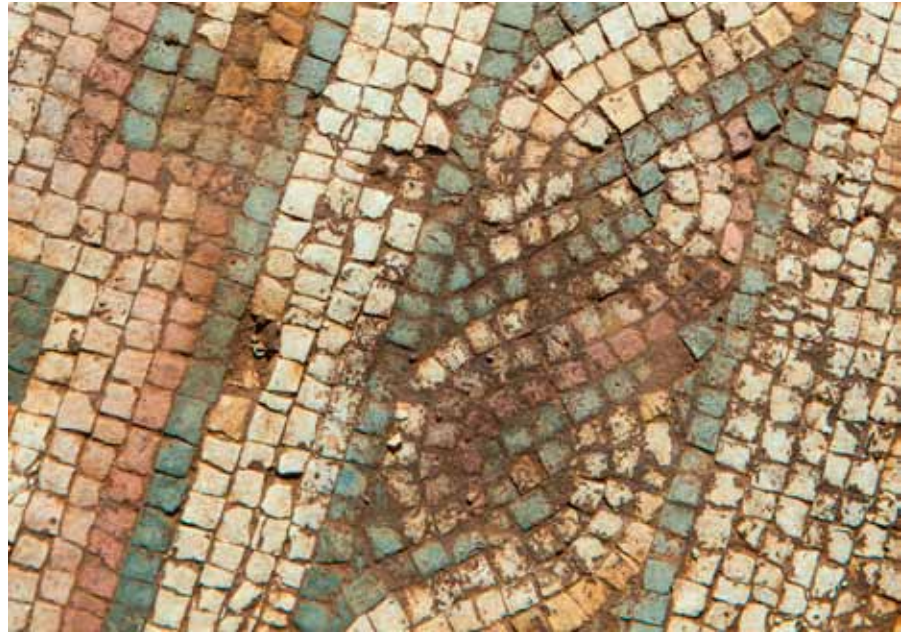
Figure 26
Detail of the black incrustations
on the *tessellatum*.

The most significant pathology identified in this pavement concerns the black incrustations that cover a large part of the motifs, but which do not interfere with their interpretation (Fig. 26).
